Property Inspection Report

LOCATED AT:
12345 Anywhere St
Green Bay, WI 54304

INSPECTED ON:
Monday, March 28, 2022

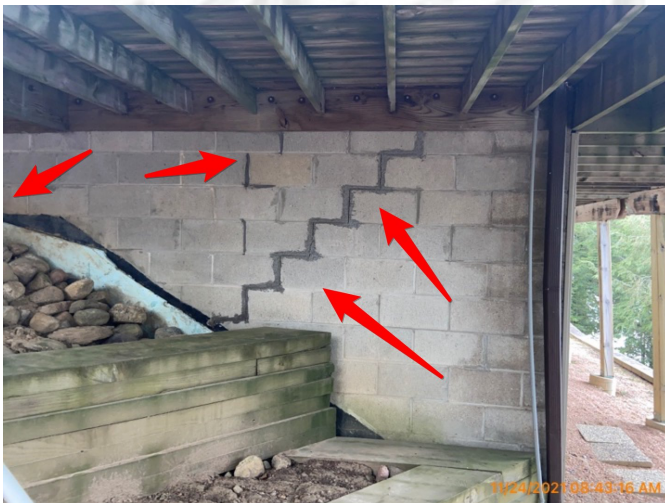
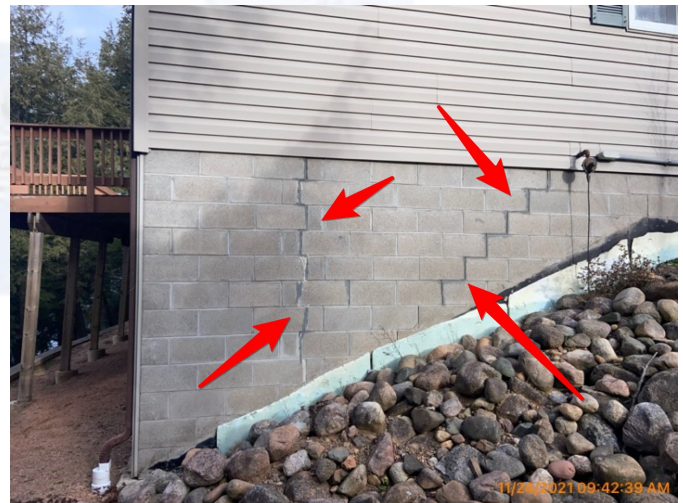
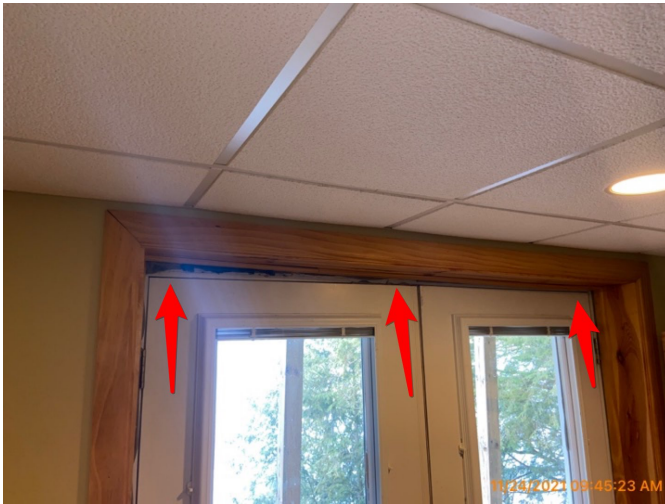
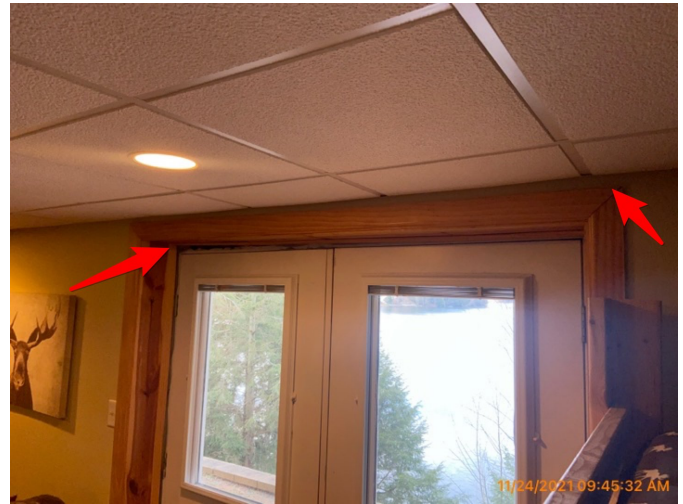
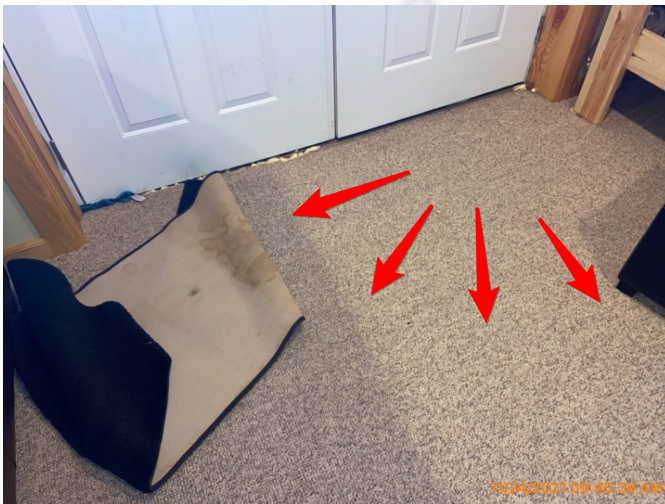
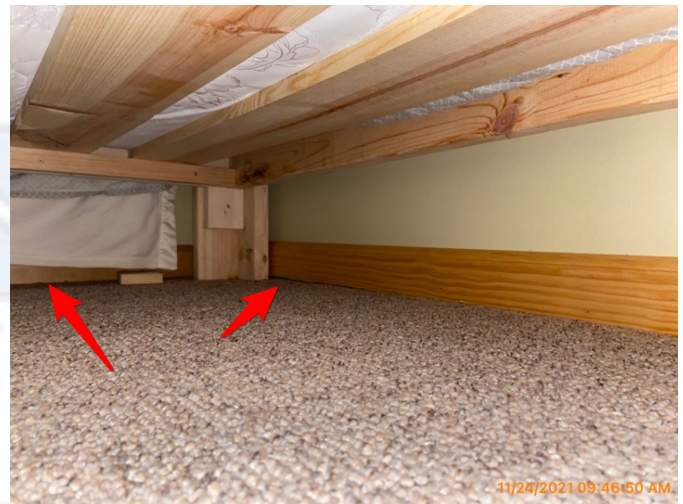
DFCT **SAFT** **CONT** A condition was observed that needs attention.

****Observed settling along foundation wall with further evidence of cracked foundation floor (concealed by carpeting) as well as base trim and trim around door opening, see additional statements in "Exterior" section of this report regarding exterior deck and retaining walls.**

Recommend immediate review of the entire structure, interior columns supports, foundation walls, elevated deck and structural supports, retaining walls and stairway leading to lakeside by a structural engineer.

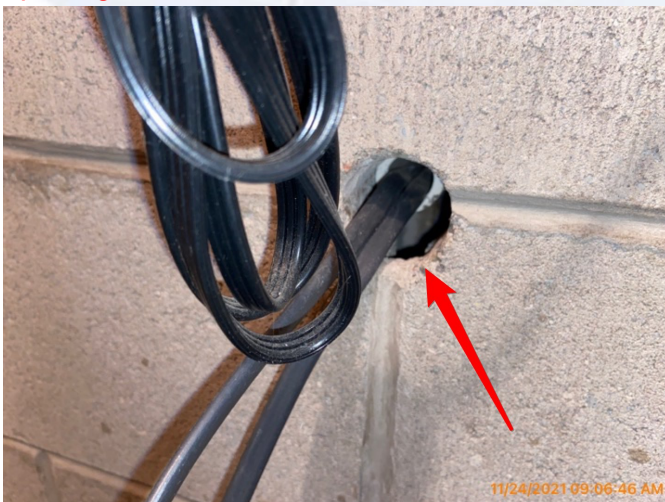
A condition was observed that needs attention.

**observed hole in block where electrical conductors (wires) run through wall, recommend sealing this opening in foundation wall

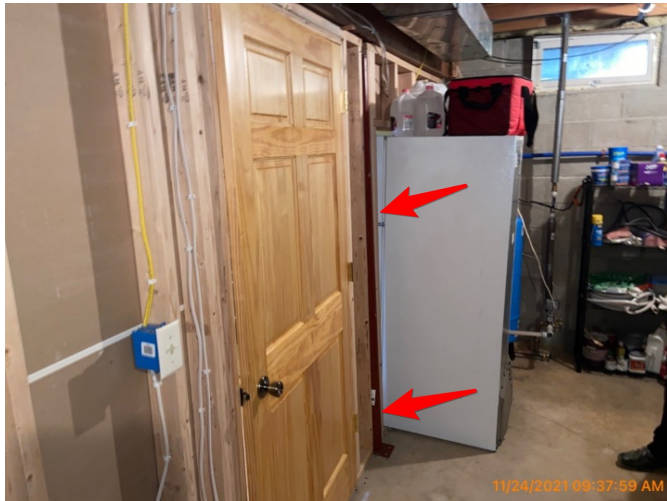
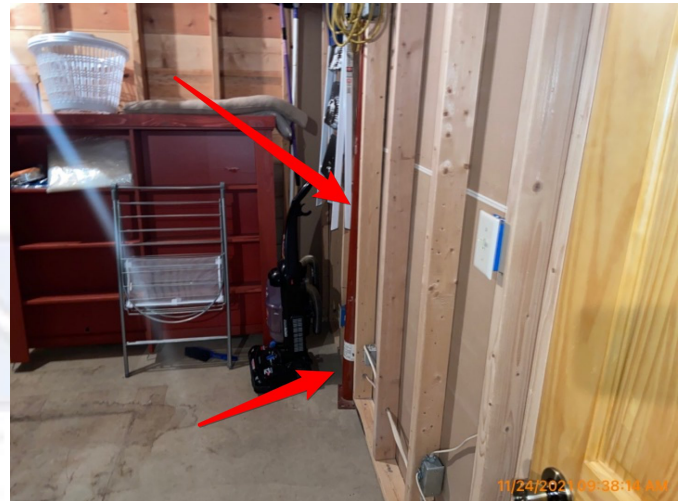
DFCT **SAFT** **CONT** A condition was observed that needs attention.

****Observed support columns as well as framed walls installed throughout center of basement are no longer plumb, recommend further evaluation by a structural engineer, this observation is deemed to be part of the structural concern addressed in "Exterior" section of this report.**

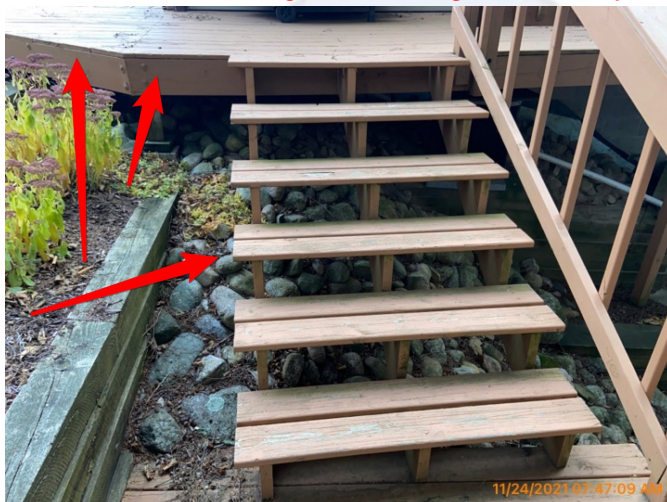
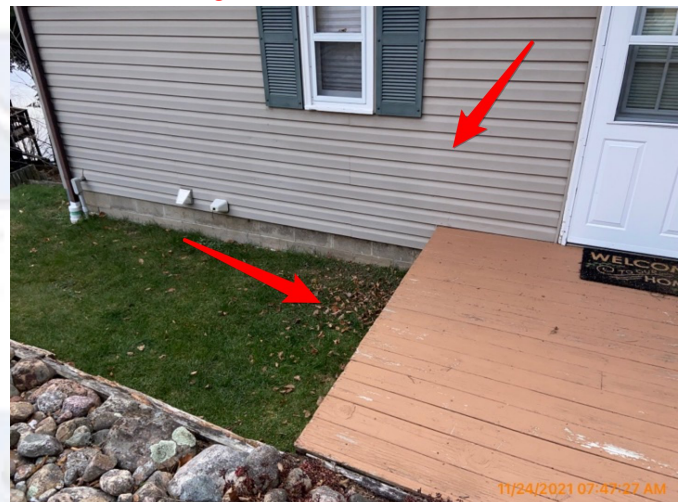
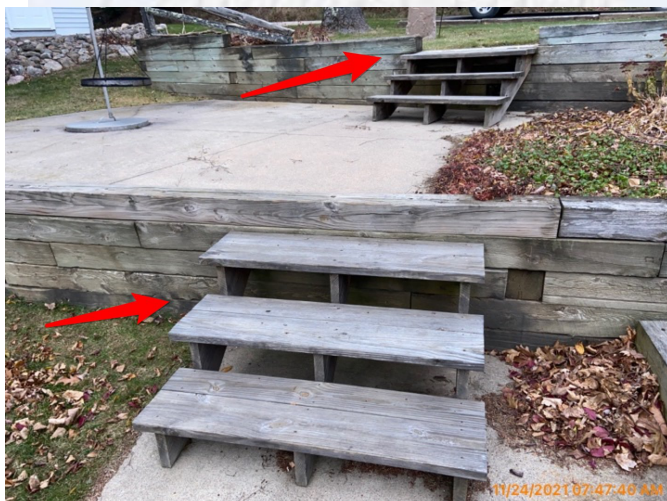
SAFT **CONT** A was observed that needs attention.

****Observed a missing hand railing for stairway, recommend installing a handrail.**

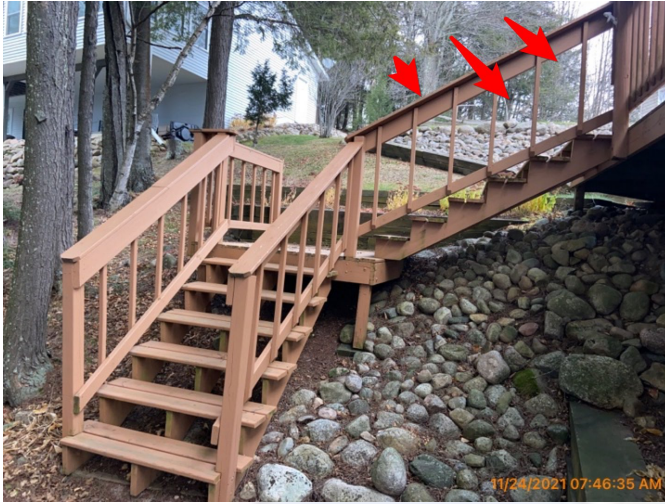
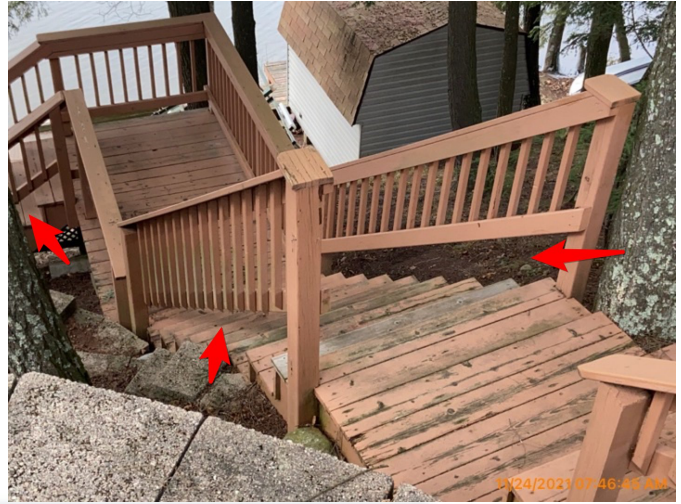
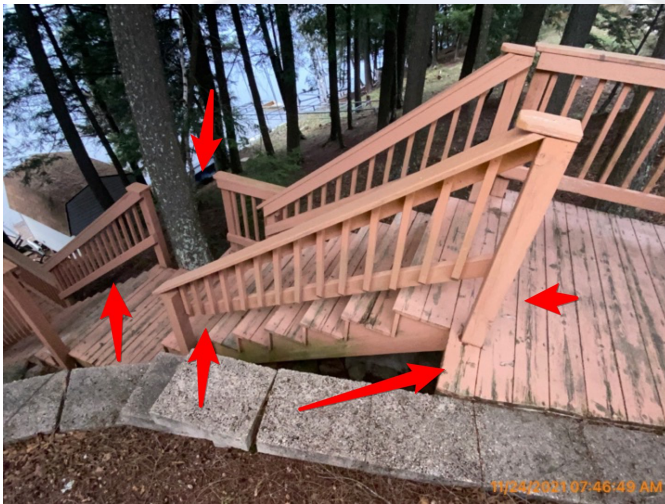
SAFT **CONT** A condition was observed that needs attention.

****Observed missing spindles or a means to limit free open space of deck railing system, recommend installing a means to limit the free open space to be 4" or less.**

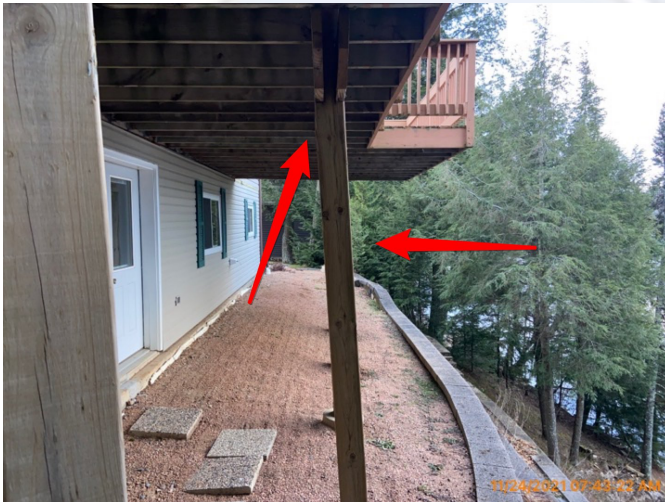
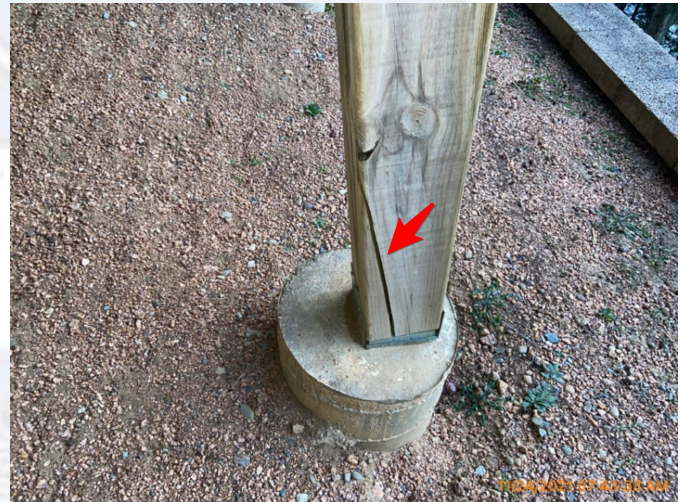
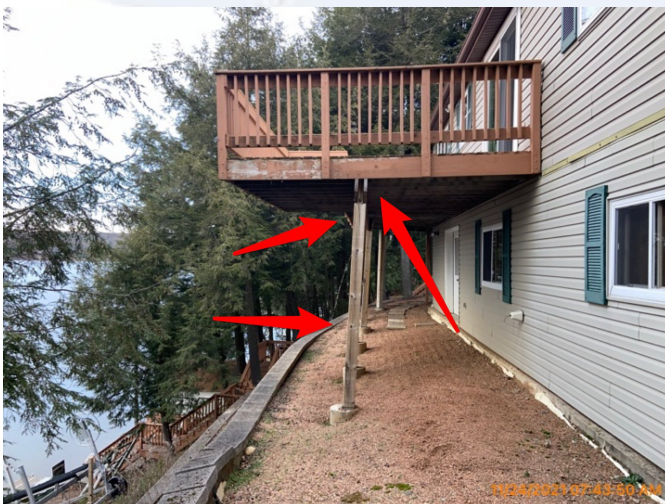
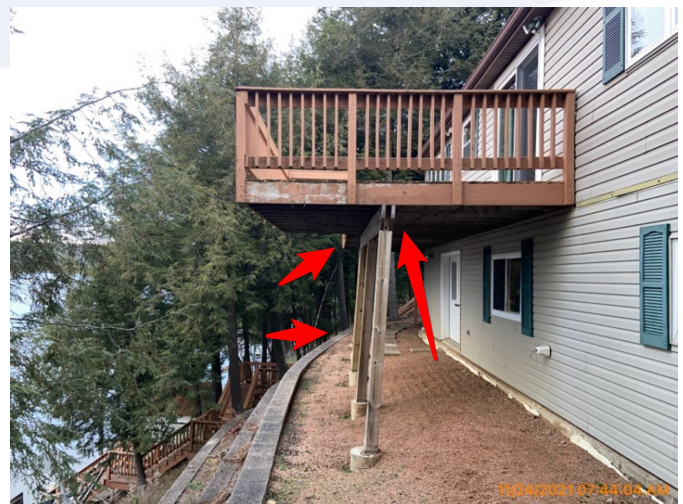
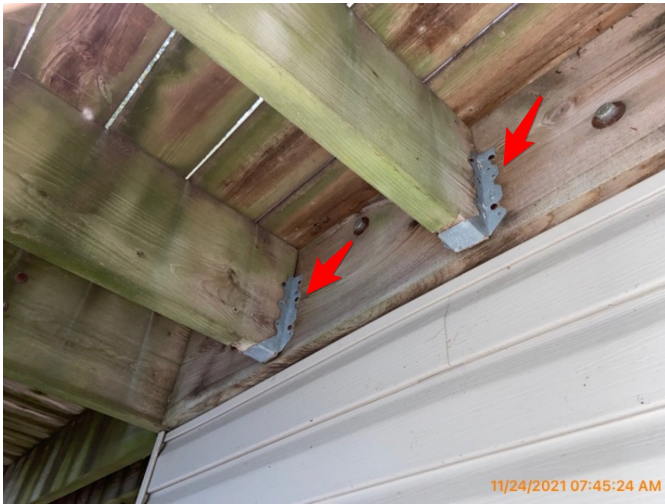
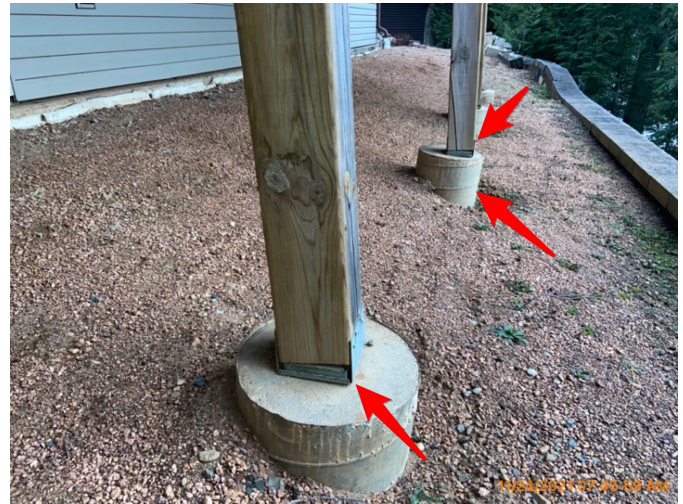
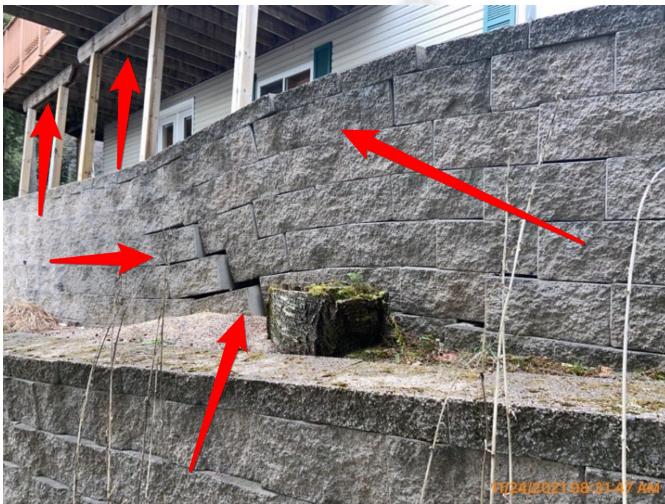
A condition was observed that needs attention.

****Observed elevated/balcony deck, structural support components are no longer plumb as well as limited structural support beams and inadequate installation of joist connections along dwelling structure, further evidence revealed this deck is near failure, recommend no longer using this elevated structure until a full comprehensive review can be conducted by a structural engineer.**

Additional observation revealed this dwelling is constructed into a steep grade hillside, the observation revealed each retaining wall is showing significant signs of settling and structural failure, further more, the dwelling foundation has evidence of step cracking as well as straight line cracking.

The Interior observation revealed settling of foundation floor near walkout door and bunkbed, finished walls installed down center of basement along with support columns are no longer plumb and may be part of this structural concern.

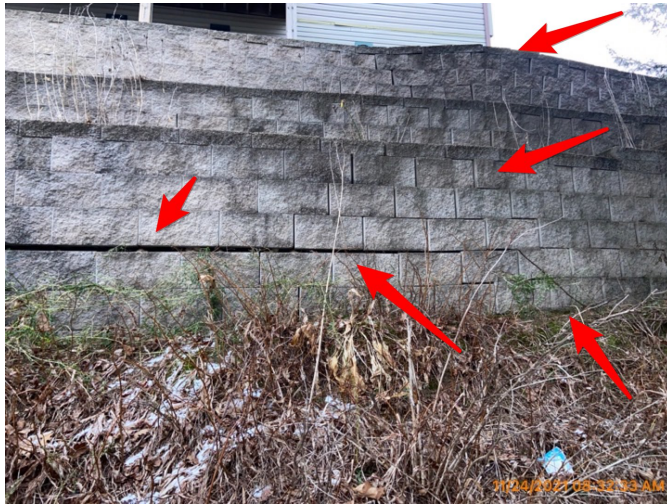
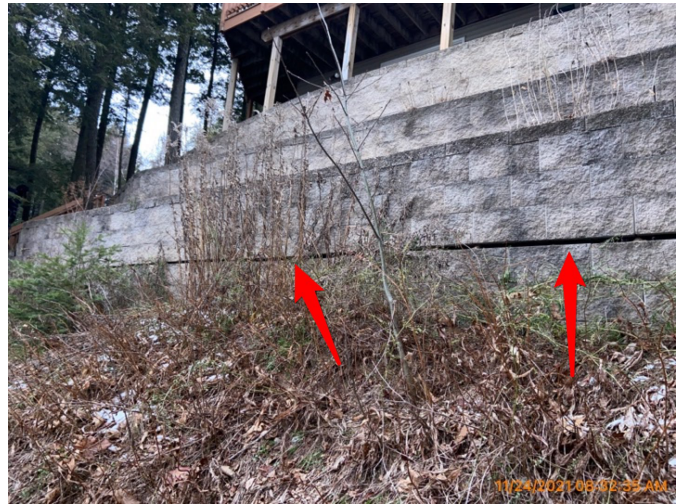
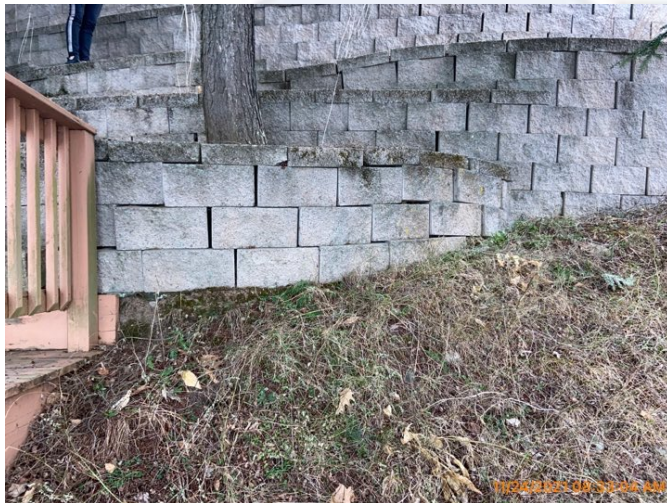
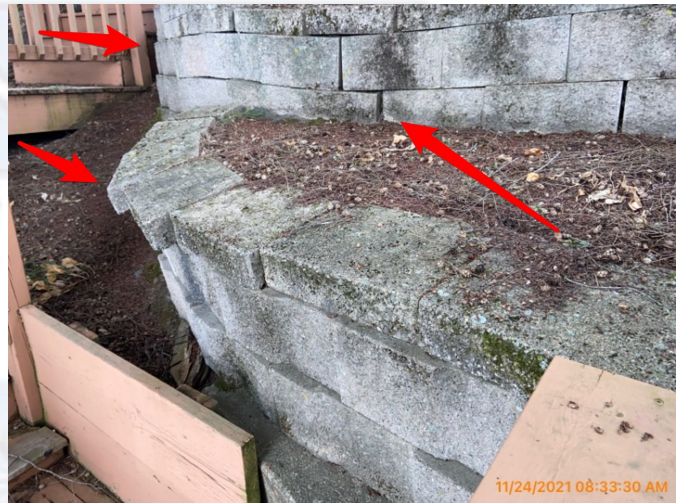
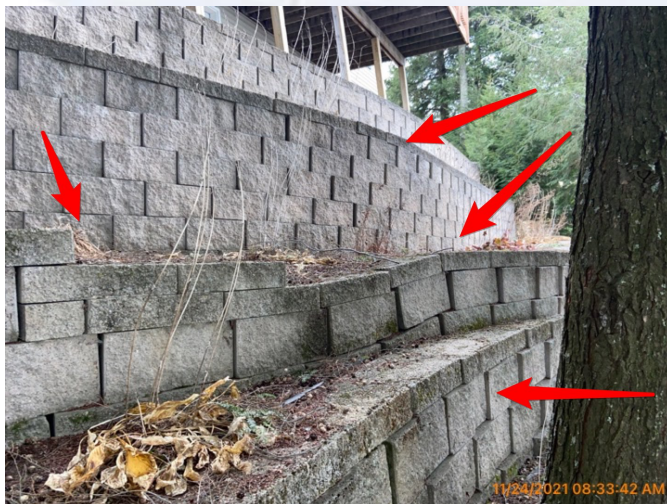
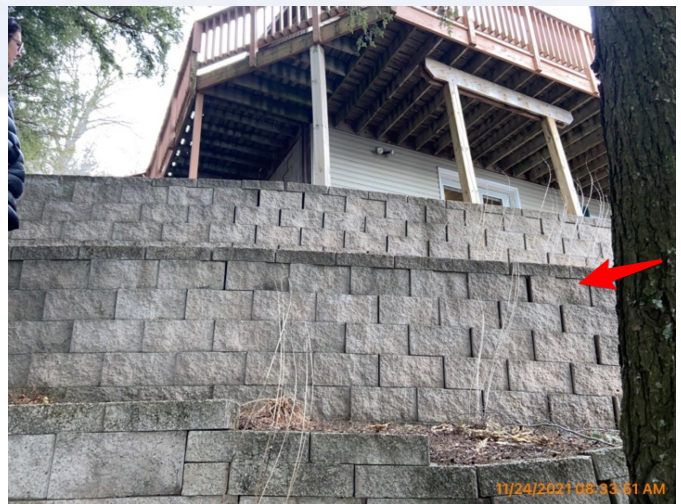
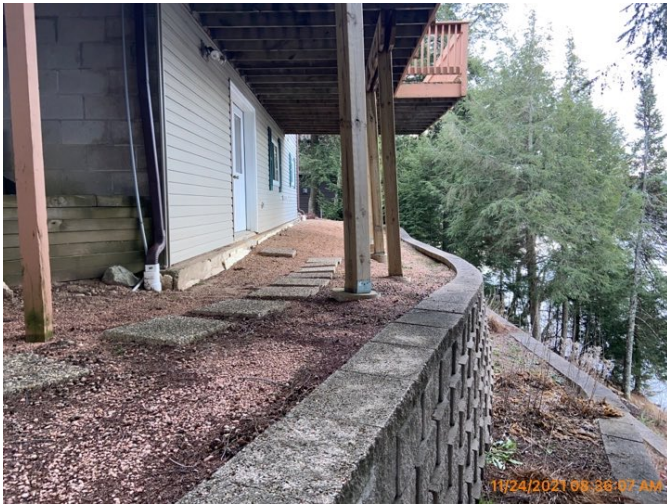
A condition was observed that needs attention.

**Observed each retaining wall, see previous notes regarding recommendations

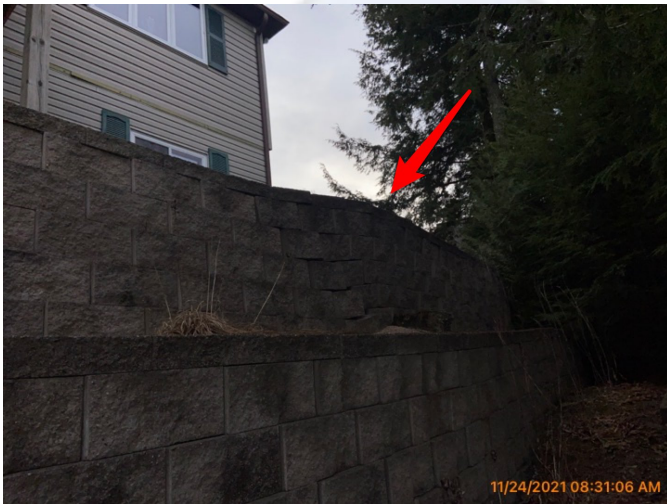
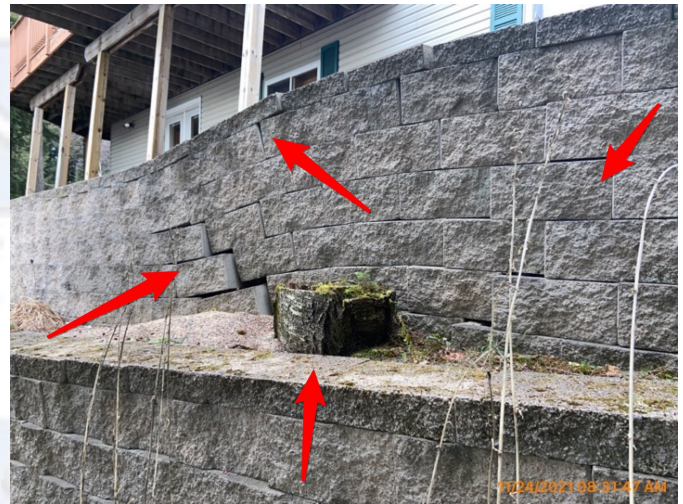
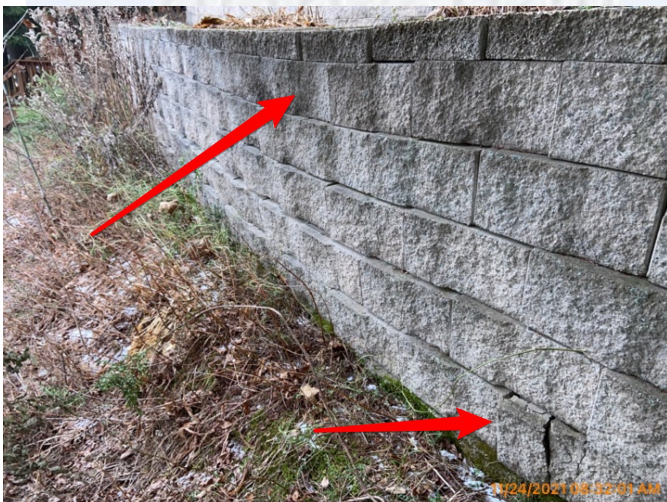
DNGR **DFCT** **SAFT** **CONT** A condition was observed that needs attention.
**additional photos of retaining walls

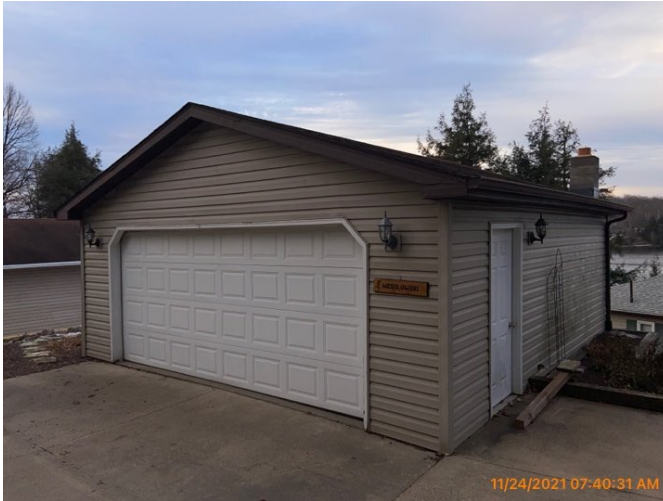
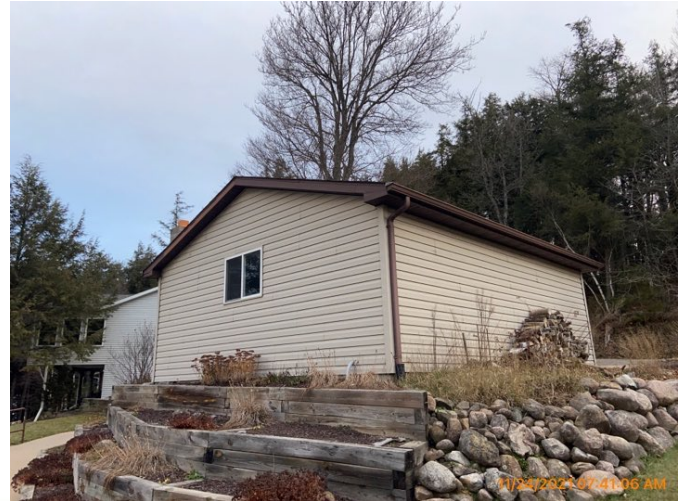
Garage Detached Detached Garage

Observed Condition(s)

OKAY No adverse conditions were observed.

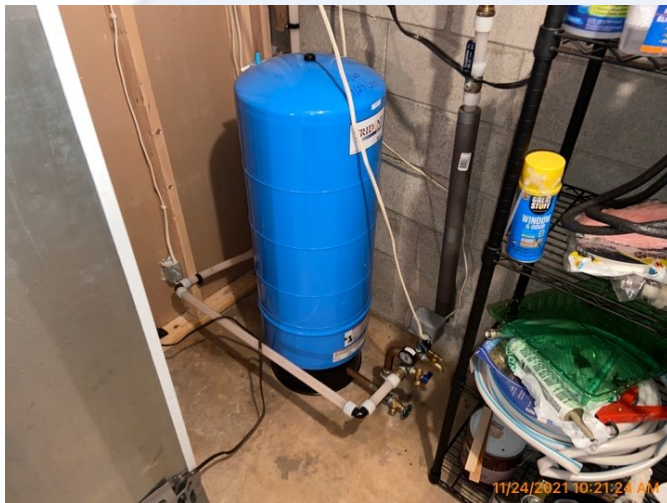
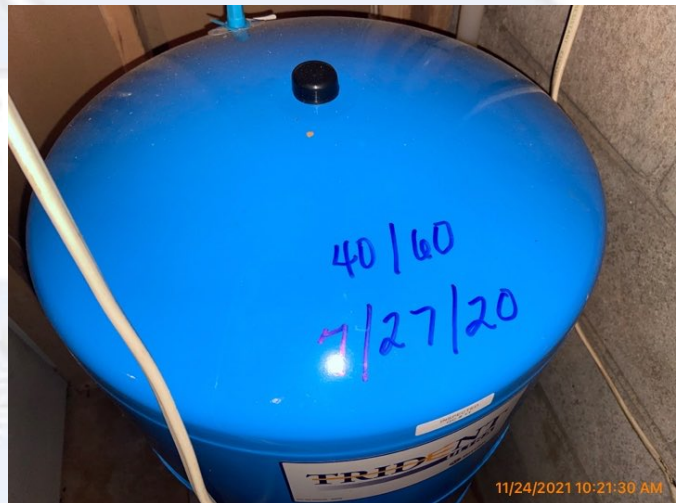
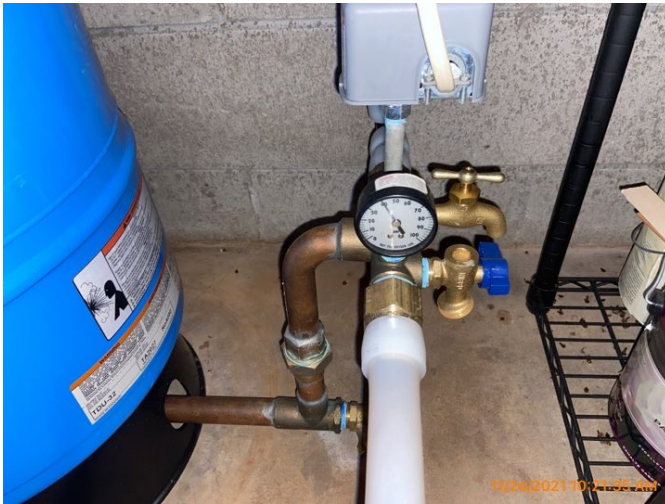
Domestic Water Supply Components

Domestic water source: Private well water, recommend well water be tested to ensure it is safe and free of contamination that could lead to adverse health conditions.

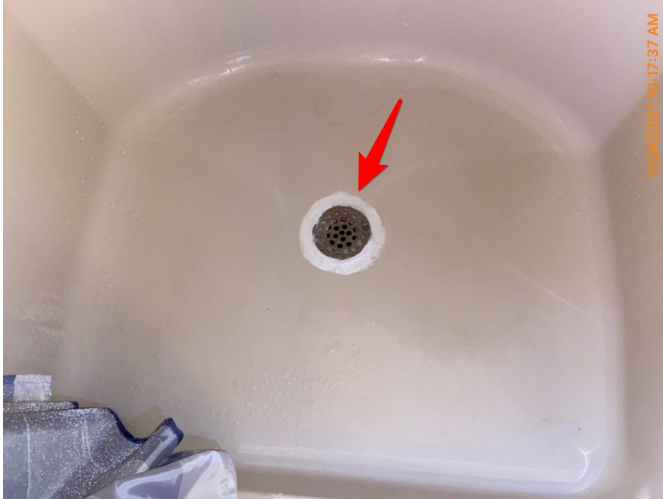
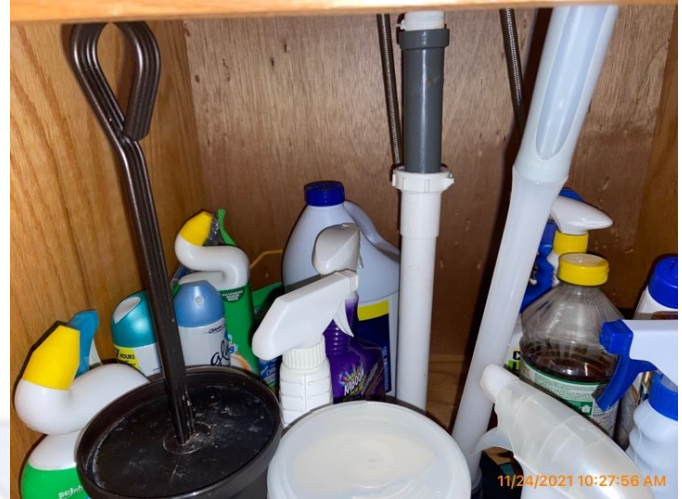
SAFT **CONT** A condition was observed that needs attention.

****Observed shower base drain is re-sealed, water pools around drain and did not fully drain without manual manipulation of standing water toward drain.**

****Observed no trap installed, trap may be concealed by ceiling finishes, recommend further review by a plumbing contractor.**

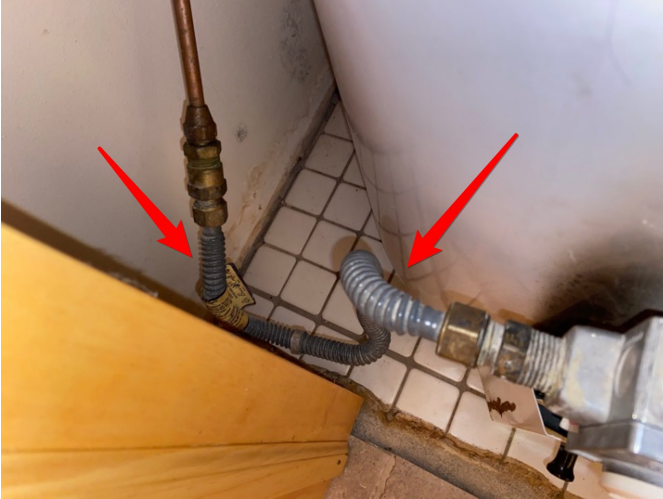
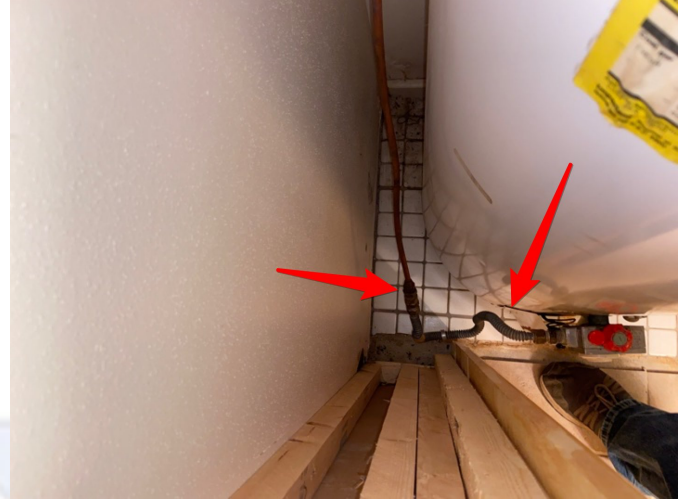
SAFT **CONT** A condition was observed that needs attention.

****Observed missing dirt leg (sediment trap) on fuel supply line, recommend a licensed plumber install one to protect fuel regulator from potential debris carried through gas line.**

****No fuel shut off observed for this water heater, recommend plumbing contractor install a fuel shutoff valve.**

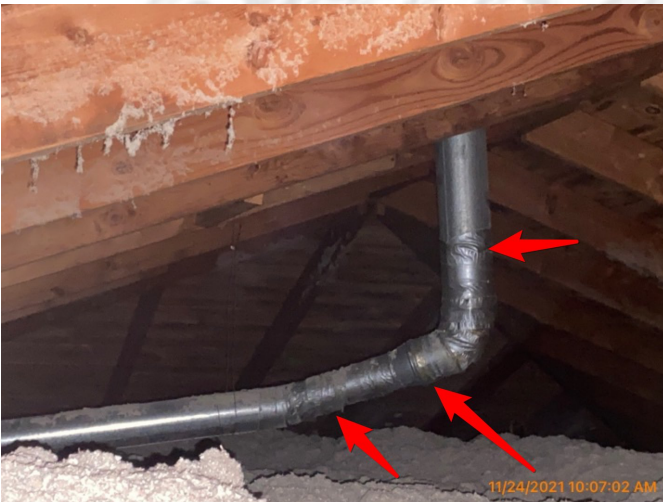
SAFT **CONT** A condition was observed that needs attention.

****Observed duct tape used to seal exhaust piping for water heater, this is not an acceptable installation practice, recommend review by a plumbing contractor**

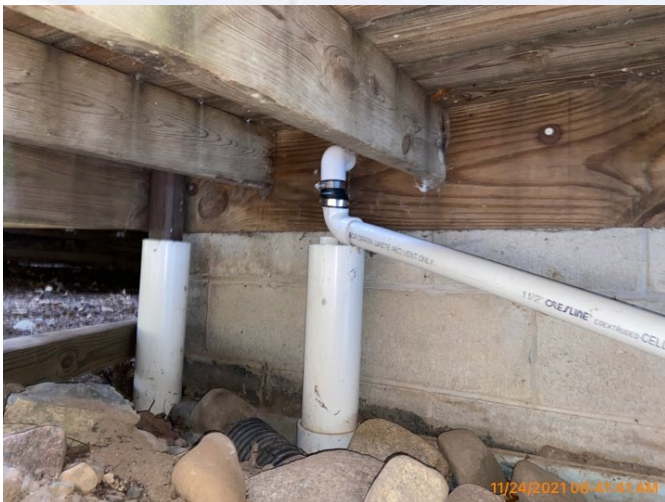
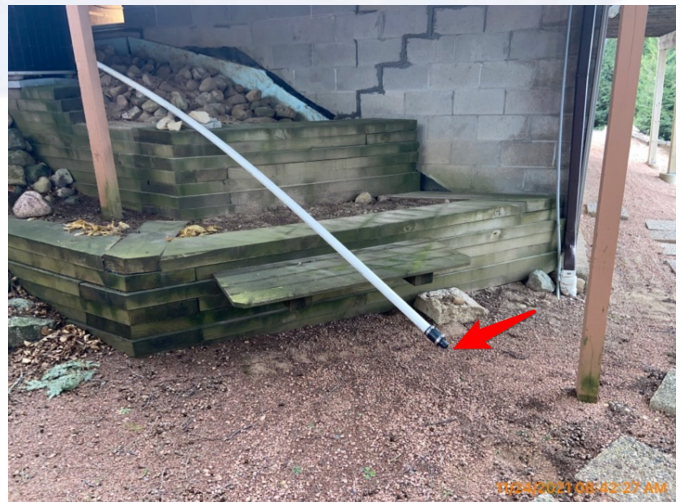
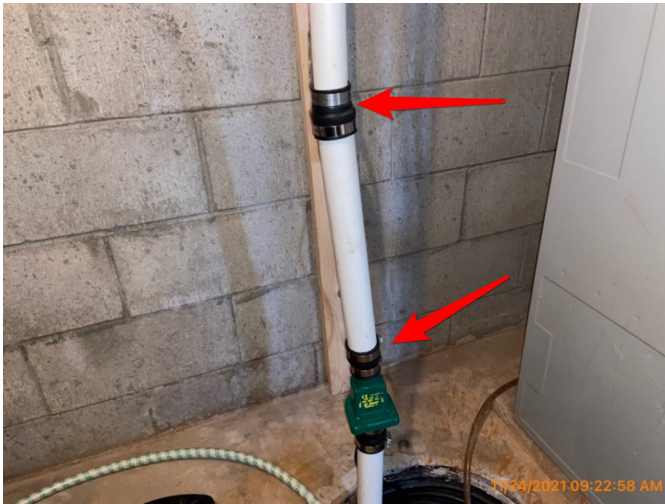
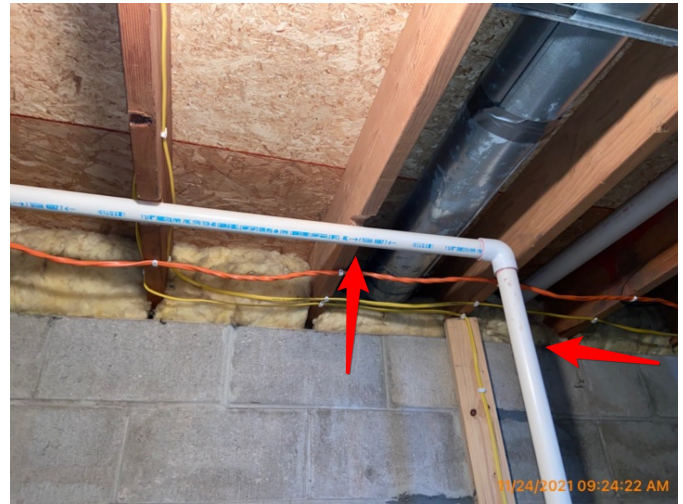
CONT A condition was observed that needs attention.

****Observed sump pump installed, the discharge pipe is re-routed to discharge out to grade near a column support for the elevated balcony, recommend re-routing this discharge point to ensure moisture is diverted away from all structural components and retaining walls.**

****Observed the discharge piping for sump pump is flexing at each joint and not properly supported, recommend review by a plumbing contractor to determine correct installation method.**

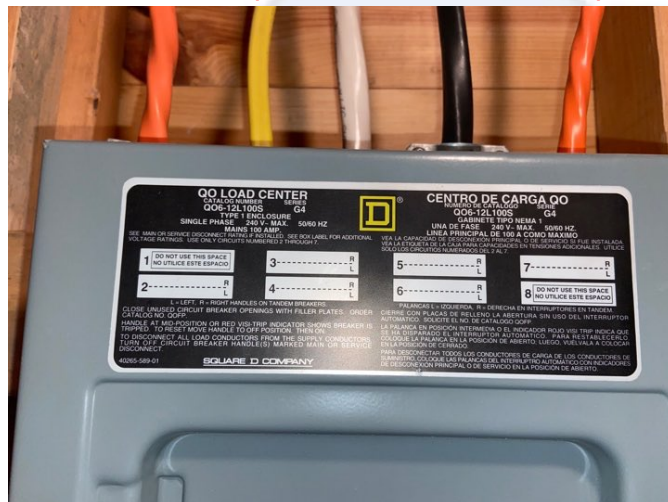
Distribution panel in furnace room

SAFT **MAIN** A condition was observed that needs attention.

****Observed incomplete data on distribution panel legend, unidentified circuits, garage and basement**

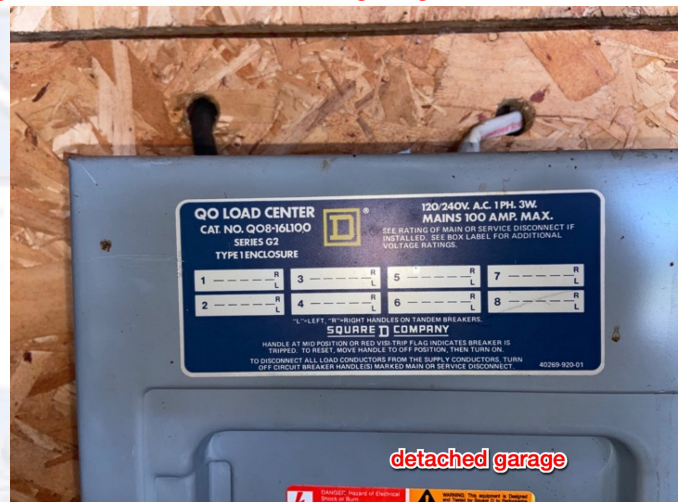
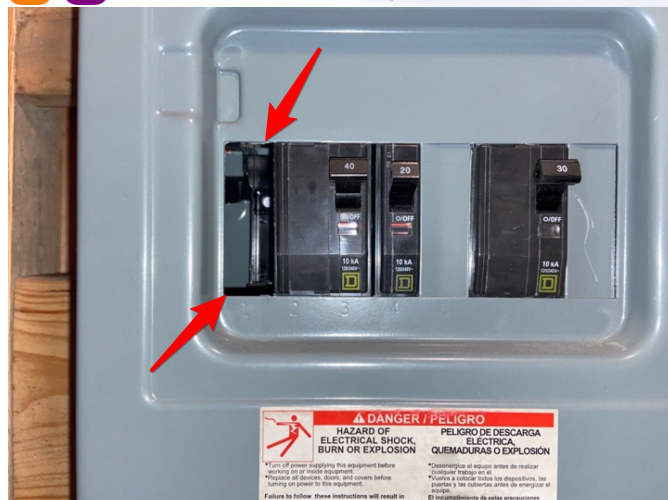
detached garage

SAFT **CONT** Panel knockouts - open

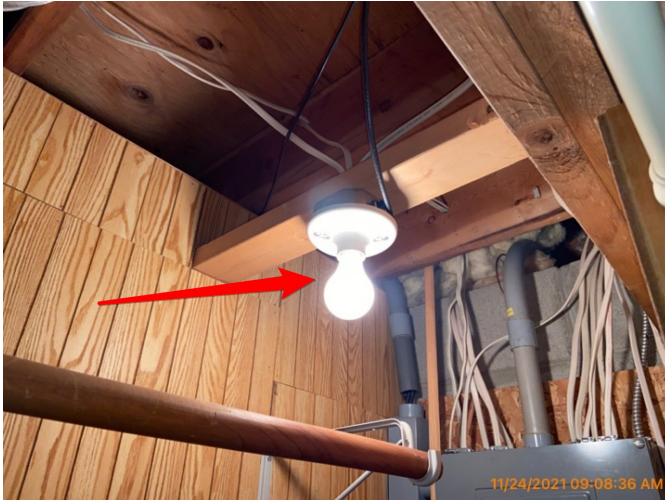
MAIN A condition was observed that needs attention.
****Observed exposed light bulb in closet, this is a potential fire hazard**

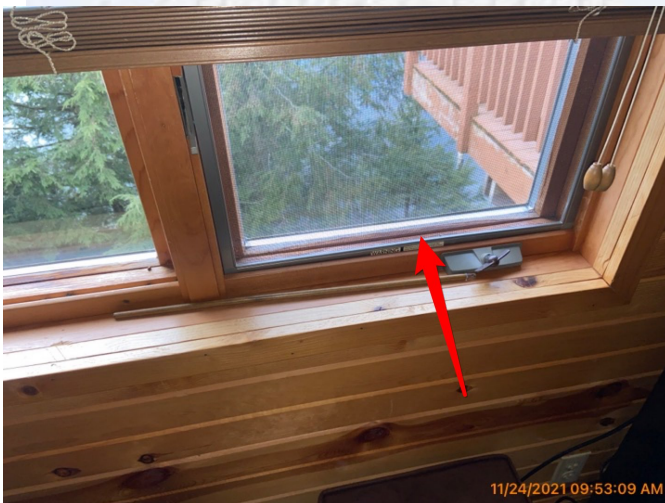
MAIN A condition was observed that needs attention.

****Observed one window did not open as designed, located in living room**

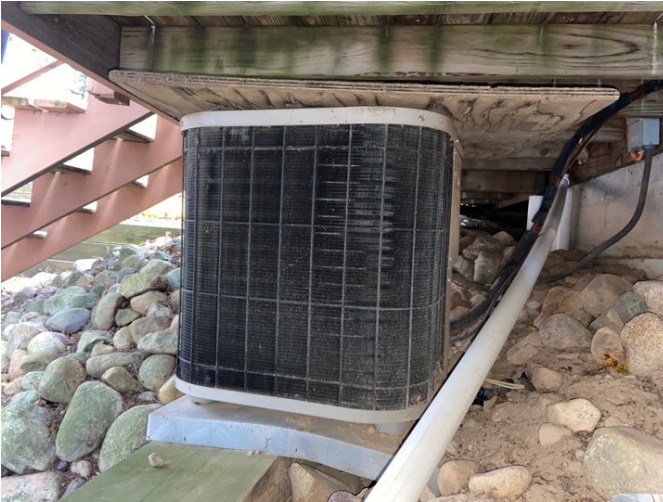
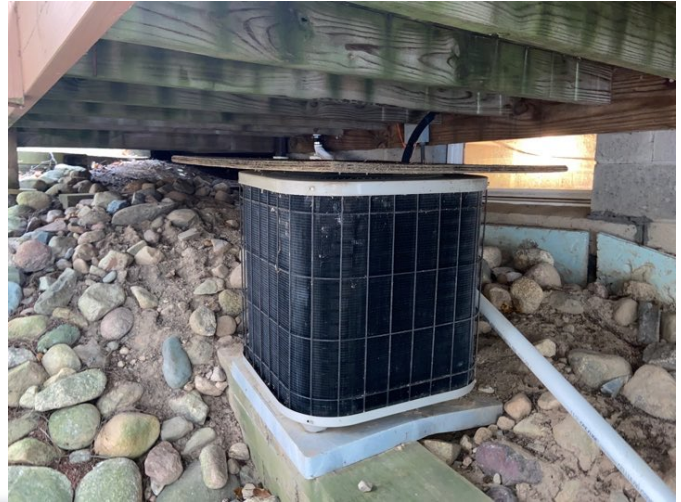
CONT A condition was observed that needs attention.

****Observed installation and method, recommend evaluation of installation location and method as well as update maintenance by an HVAC Technician.**

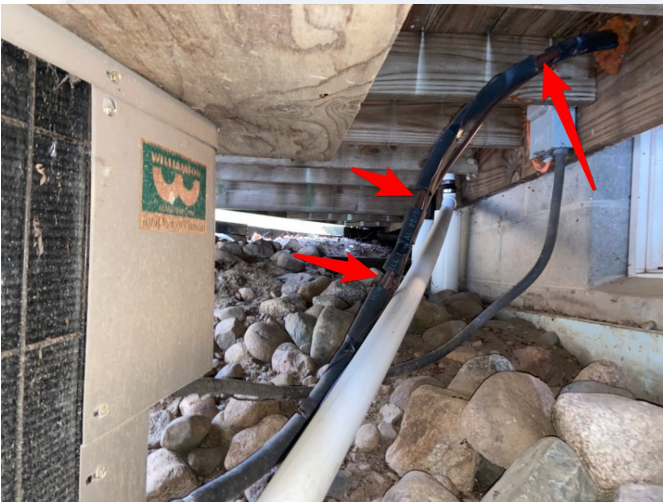
CONT A condition was observed that needs attention.

****Observed Insulation to be weathered and/or missing, recommend repairing as necessary to ensure efficient operation of condensing unit**

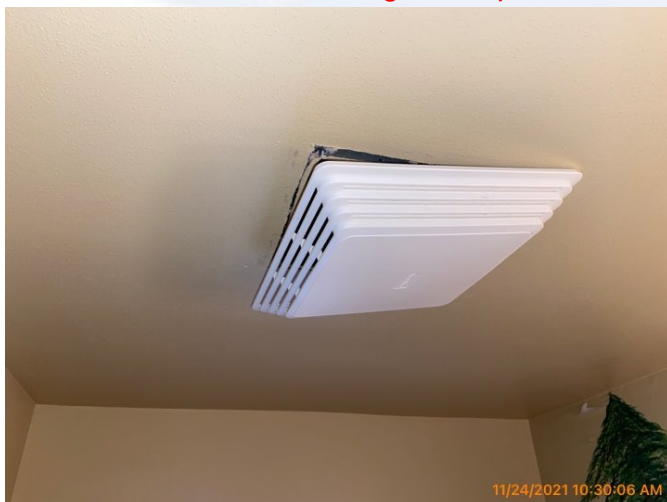
CONT A condition was observed that needs attention.

****Observed bathroom ventilation, unable to determine discharge point of ventilation, may be too attic and not to exterior of building envelope, recommend evaluation by an HVAC Technician.**
